# Manhole Inspection Summary

Manhole # S43E2\_003MH

Insp Date: **1/2/08 8:19 AM**

**Location** Address: **1200 Church St**

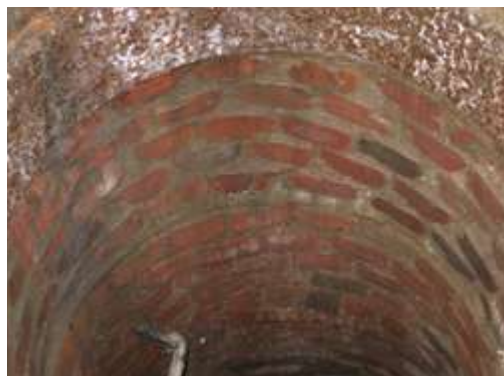
Defect 1

Infiltration: ☐ None ☐ Joint ☐ Cracks ☒ Mortar ☐ Roots ☐ Wall

Mortar

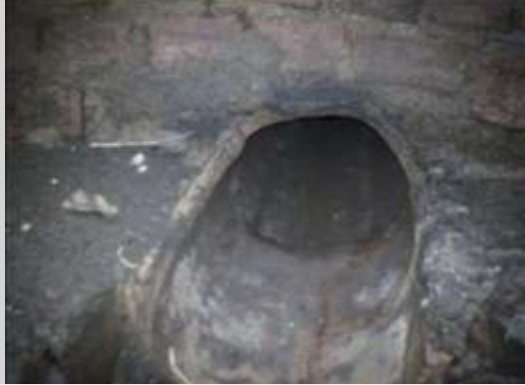
12 O'Clock Outflow

10 in. Circular Gravity Sewer  
Pipe Out @ 12 O'Clock

Infiltration: **None** Pipe Seal Cond: **Sound**

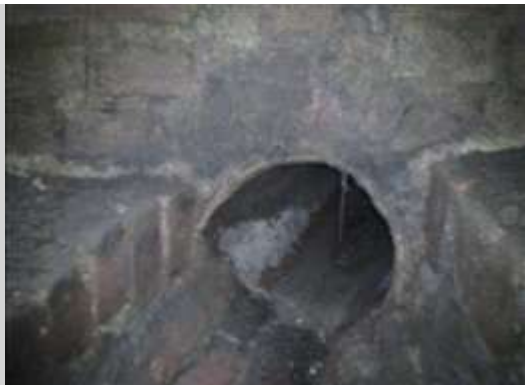
3 O'Clock Inflow

10 in. Circular Service Sewer  
Pipe In @ 3 O'Clock

Infiltration: **None** Pipe Seal Cond: **Sound**

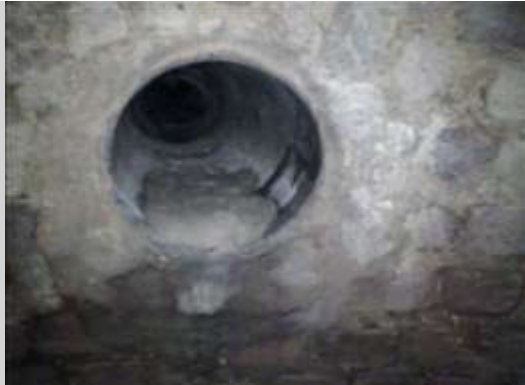
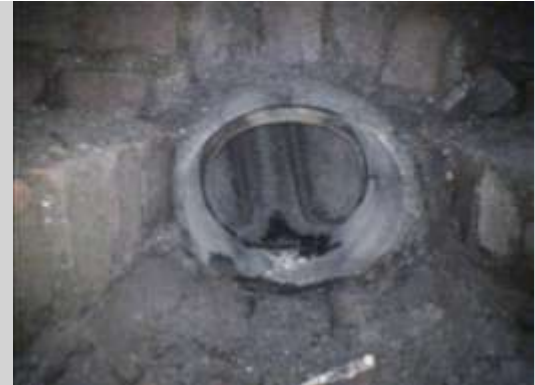
7 O'Clock Inflow

10 in. Circular Gravity Sewer

Pipe In @ 7 O'Clock

Drop In @ 7 O'Clock

Infiltration: **None** Pipe Seal Cond: **Sound**

Drop Condition: **Open**
